# Operating Experience Summary

## Office of Nuclear and Facility Safety

May 13 — May 25, 2000

Summary 2000-10

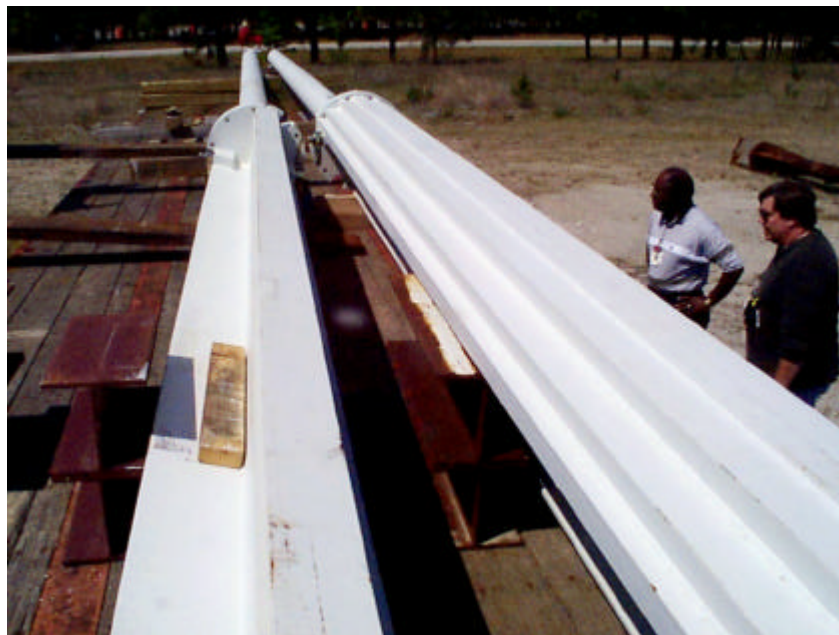
Two 48-foot long mixer masts were being loaded onto a flatbed truck at the Central Shops facility. (See Figure 1.) One mixer mast had already been loaded and a second was being loaded with a forklift. Each mixer mast weighed more than 5,000 pounds. The job foreman supervised the loading of the first mixer mast and then left the area to attend to collateral duties. The unsupervised crane operator stood on the bed of the truck next to the loaded mast. The second mast shifted when the tines of the forklift tilted, and it rolled as it contacted the truck bed, pinning the crane operator's leg between the two masts. The crane operator was driven by ambulance to the Savannah River Area infirmary where the wound was stabilized. The operator was then driven to University Hospital for x-rays and stitches. No fractures were found and, after treatment, the operator was released and returned to work.

**Figure 6-1. Mixer Masts on Flatbed**

Investigators determined that the forklift driver failed to recognize the hazard created by tilting the forks supporting the unsecured mast while the crane operator was standing directly in the path of the oncoming mast. Management had not prepared a job hazard analysis for loading and unloading irregularly shaped pieces of equipment like the

mixer masts. The work plan did not identify possible types of flatbeds for this job or similar jobs. A crane lift may have been more appropriate than the unstable forklift. Investigators believe the root cause of the incident was the crane operator placing himself in harms way and management allowing the risky behavior to be a part of the job task during the loading process.

- An evaluation should be performed to identify the appropriate equipment to use for this type of job;
- An evaluation should determine the type of cribbing to use for this type of job or similar jobs;
- A job hazard analysis for a truck loading operation should include flatbed height and be part of the work planning process;
- 29 CFR 1910.178 m and o (*Truck Operations* and *Loading*, respectively) should be integrated into the Training and Rigging Procedures.
